RDT 01-012

Bridge Deck Condition Studies in Missouri Utilizing Ground Penetrating Radar

RI 98-001

Final Report

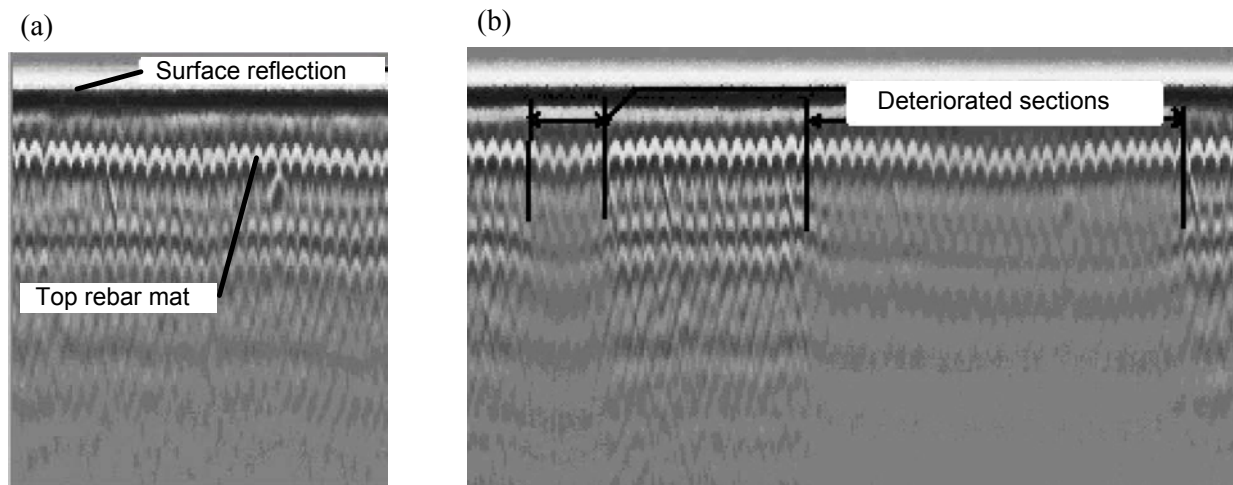
Figure 1. Example from St Charles bridge (#A9012): (a) consistent signature from the top-rebar mat; (b) signature displaying amplitude and travel-time anomalies distinguishing areas of possible deterioration.

Figure 1 shows example data, displaying radar reflection profiles across areas where the radar signal is clearly interpretable. Where the amplitude and travel time (depth) of the radar returns are laterally continuous, the bridge is determined to be in good condition. Where there are amplitude and phase (travel time) variations, areas of possible deterioration can be mapped.

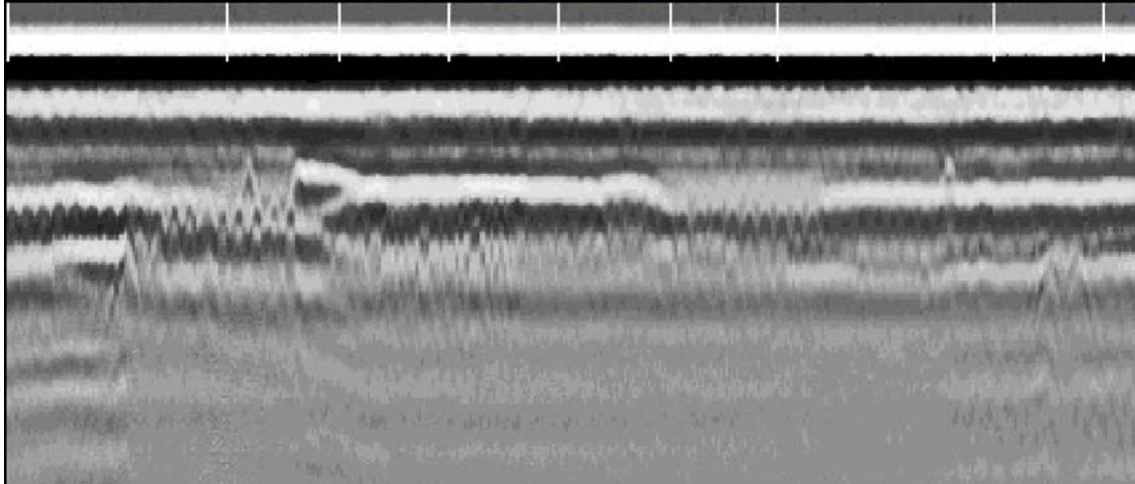
Figure 2. Example bridge L964R North, Kingdom City, MO. Lateral amplitude and phase variations, perhaps due to design and construction, make interpretation more challenging in terms of possible deteriorated sections.

Figure 2 shows an example where interpretation is more difficult due possibly to design/construction variation.

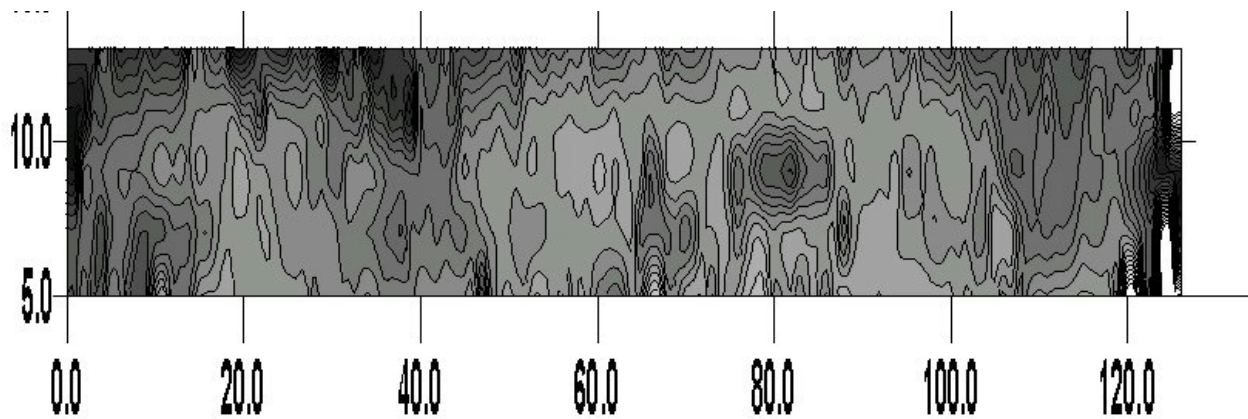
Figure 3a. Map-view of rebar reflection amplitude contoured after data analysis of bridge #A9012 (St. Charles). Dark spots are “hot”, associated with loss of radar amplitude indicating that bridge integrity in those areas may be compromised.

The degradation of the radar signal shows up as a loss in amplitude of the rebar reflection and an increase in travel time to the rebar layer. Both of these changes in signature are indications that the rebar is deteriorated and the region above the rebar is compromised in some fashion. Although no imaging of debonding or delamination is measured directly, the radar reflection character is related directly to the amount of debonding/delamination, which allows (chloride-bearing) fluids to reach the rebar mat. After detailed visual assessment and/or amplitude mapping, a contour plot of each bridge deck showing good and bad areas is produced. Where visual assessment was not possible (Figure 2), only variation in the radar reflection amplitude from the top rebar mat is used as an indicator of possible deterioration. Using strictly a visual assessment, a black and white result (i.e., it is either bad or good) is determined automatically. Using the character of the top rebar mat, the result is a contour plot of amplitude or two-way travel time (indicative of velocity variation) that is more of a continuum. These plots must be calibrated in order to determine what the cut-off values must be for determining good versus bad. Figures 3a and 3b display interpretation results for bridge #A9012 (St Charles) where rebar amplitude mapping was used.

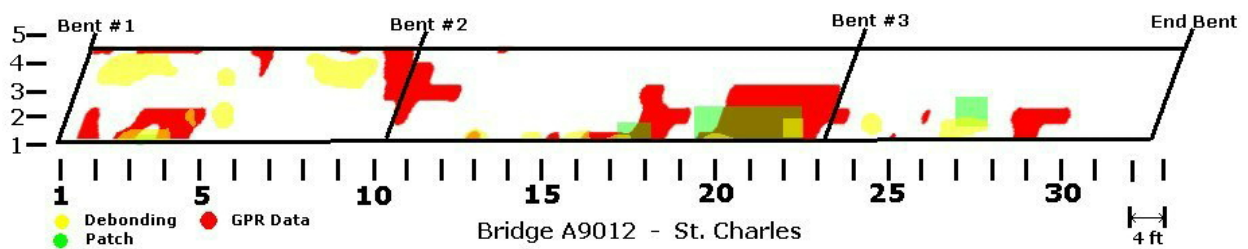
Figure 3b. Map-view of interpreted condition assessment after rebar reflection amplitude analysis of bridge #A9012 (St. Charles). Colored spots highlight surface patches as well as debonding determined by chain drag testing.

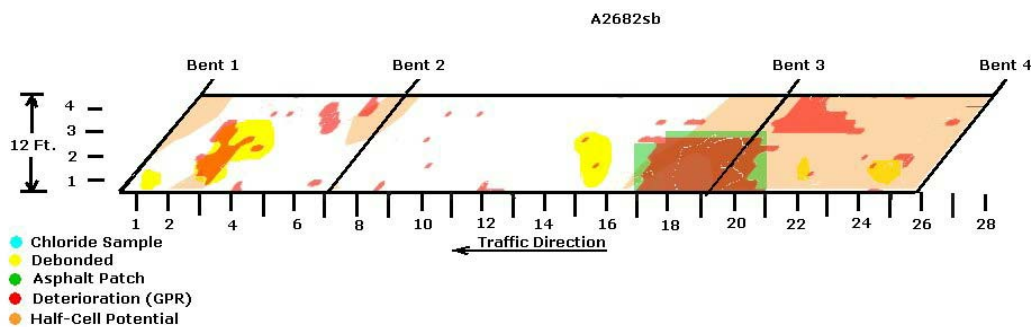
Figure 4. Map-view of interpreted condition assessment after visual analysis of radar data for bridge #A2682 southbound (Arnold). Colored spots highlight surface patches as well as debonding determined by chain drag testing. Also plotted are half-cell potential results and chloride sample locations.

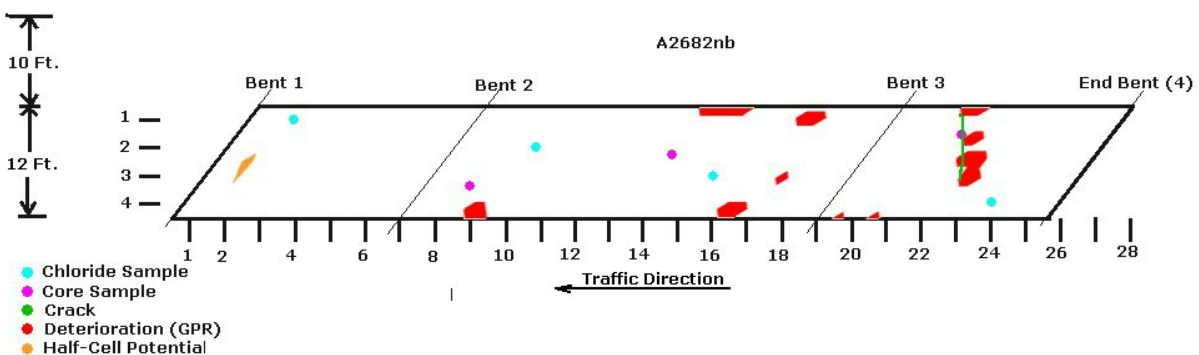
Figure 5. Map-view of interpreted condition assessment after visual analysis of radar data for bridge #A2682 northbound (Arnold). Colored areas highlight surface cracking as well as core and chloride sample locations. Also plotted are half-cell potential results.

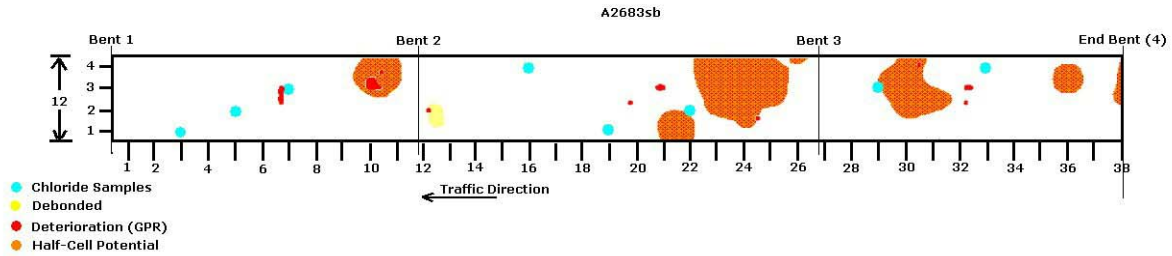
Figure 6. Map-view of interpreted condition assessment after visual analysis of radar data for #A2683 southbound (Arnold). Colored areas highlight debonding (determined by chain drag testing), half-cell potential results, and locations of chloride sampling.

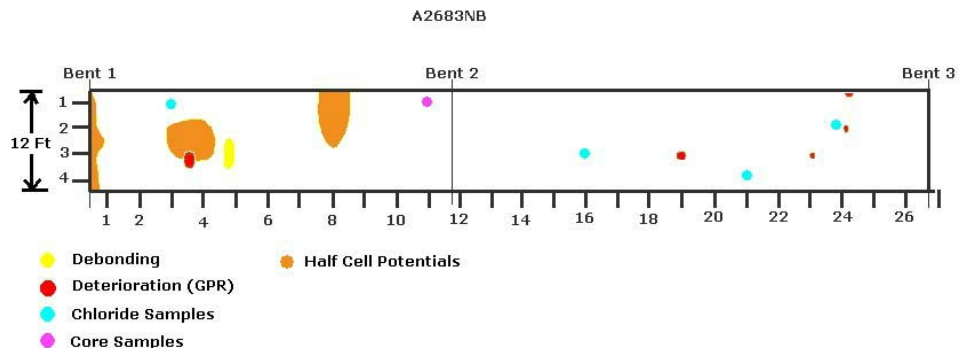
Figure 7. Map-view of interpreted condition assessment after visual analysis of radar data for #A2683 northbound (Arnold). Colored areas highlight debonding (from chain drag testing) and half-cell potential results. Also noted are core and chloride sample locations.

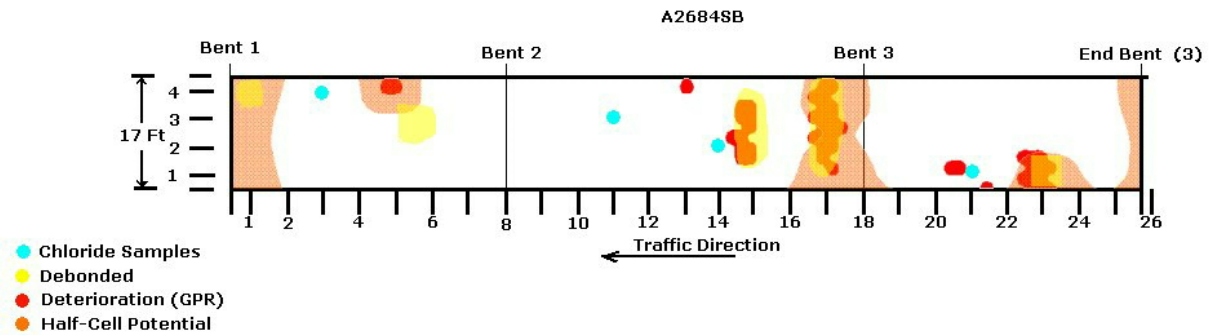
Figure 8. Map-view of interpreted condition assessment after visual analysis of radar data for #A2684 southbound (Arnold). Colored spots highlight debonding (determined by chain drag testing) and half-cell potential results. Also noted are chloride sample locations.

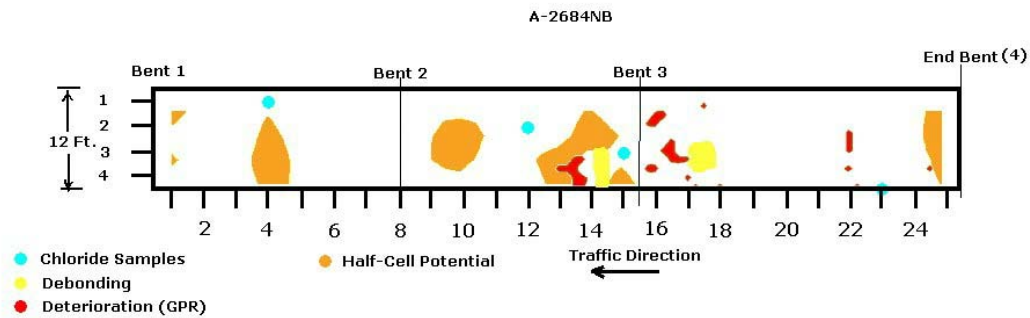
Figure 9. Map-view of interpreted condition assessment after visual analysis of radar data for #A2684 northbound (Arnold). Colored spots highlight debonding (determined by chain drag testing) and half-cell potential results. Also noted are chloride sample locations.

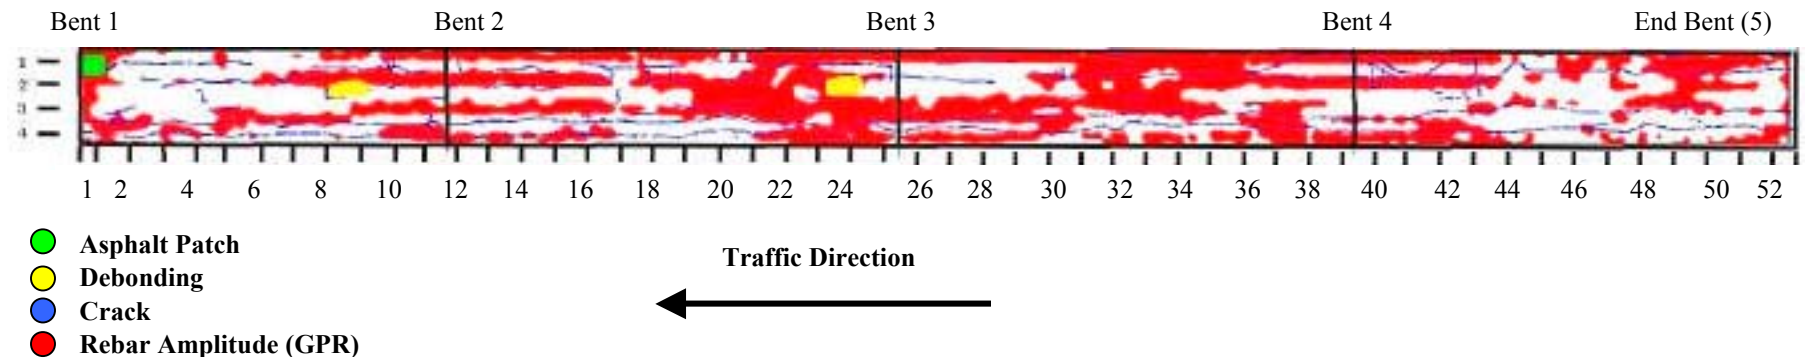
L964Rnb

Figure 11. Map-view of interpreted condition assessment after rebar reflection amplitude analysis of bridge #L964R northbound (Kingdom City). Colored areas highlight surface patches and cracks as well as debonding as determined through chain drag testing.

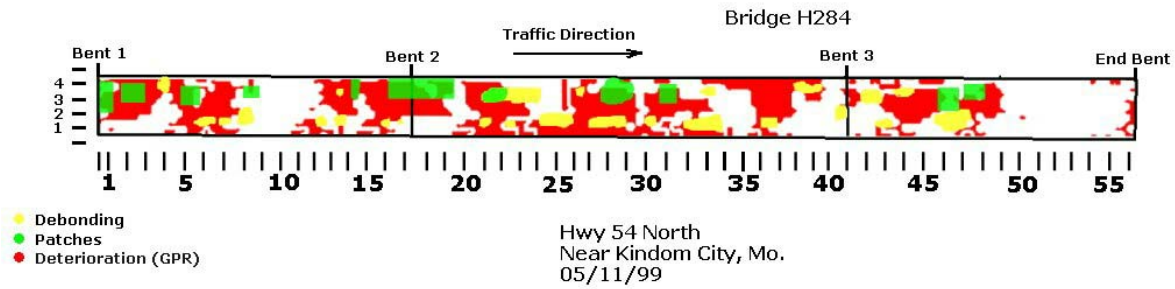
Figure 12. Map-view of interpreted condition assessment after visual analysis of radar data for bridge #H284N (Kingdom City). Colored spots highlight surface patches as well as debonding determined by chain drag testing.

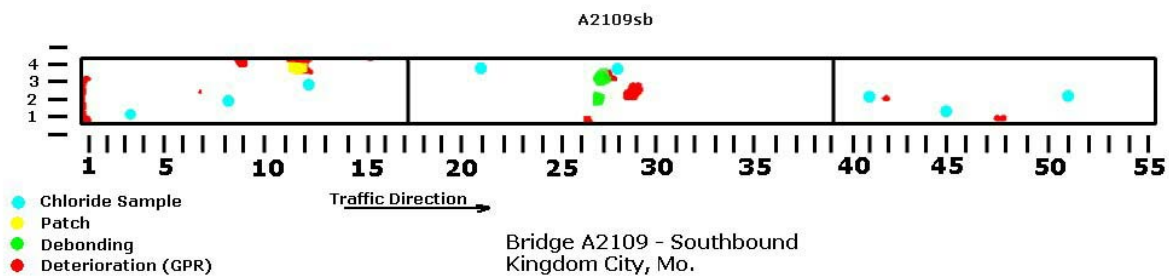
Figure 13a. Map-view of interpreted condition assessment after visual analysis of radar data for bridge #A2109 (Kingdom City). Colored areas highlight surface patches as well as debonding determined by chain drag testing. Chloride sample locations are noted.

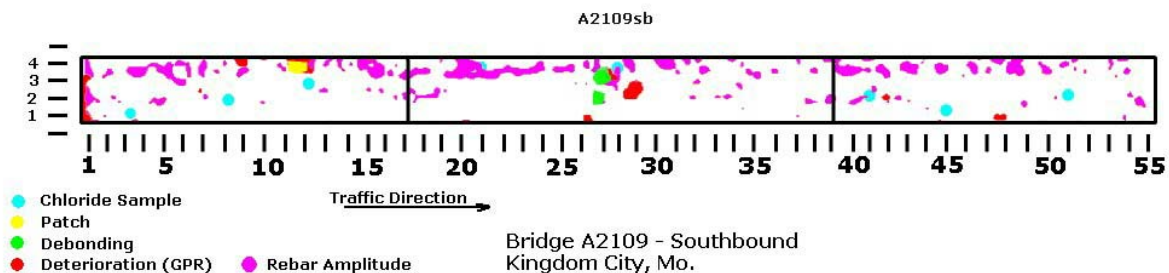
Figure 13b. Map-view of interpreted condition assessment of bridge #A2109 (Kingdom City). Colored areas highlight same features as in Figure 13a with results from rebar amplitude analysis shown as well.
